NOTICE OF PROPOSED ACTION
NOPA AZ-070-2003-8560-1
EA-AZ-070-2003-0002

Wilderness Area – Swansea Wilderness

1. Type of Action: Repair of Swansea Wilderness Barriers.

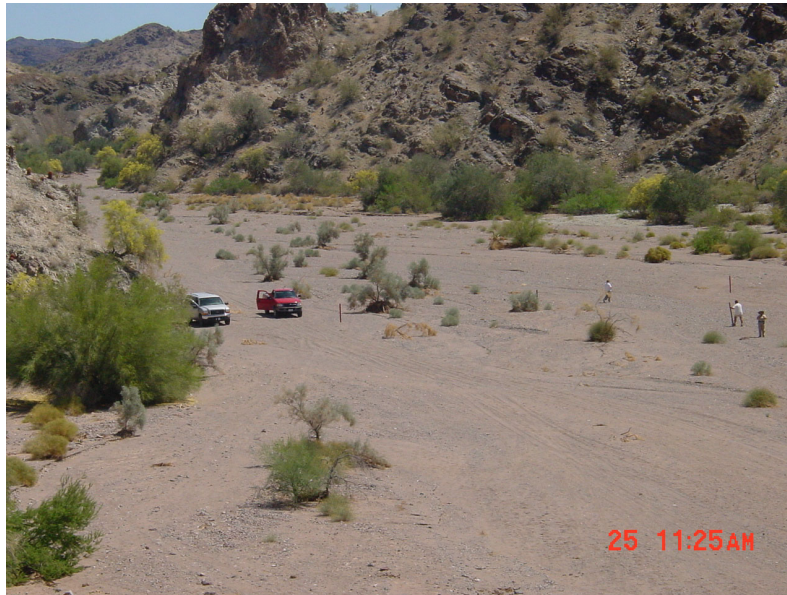
Remaining Barrier at Centennial Wash

The proposed action will replace the lost portions of the existing barrier with a line of 3-foot high, 2-to-3 feet apart, 12-inch diameter wooden bollards (recycled power poles). The bollard/barriers are less susceptible to washouts and damage by vehicles as smaller segments of a barrier are damaged during flooding without a connecting cable. The bollards do not stop motorcycles but as OHV traffic in the area is typically the larger 4x4 vehicles this should not be concern. The remaining post and cable barrier will be replaced with bollards when no longer functional. A new barrier will be placed along 300 feet of northeast edge of the wash on the wilderness boundary to protect sensitive resources.

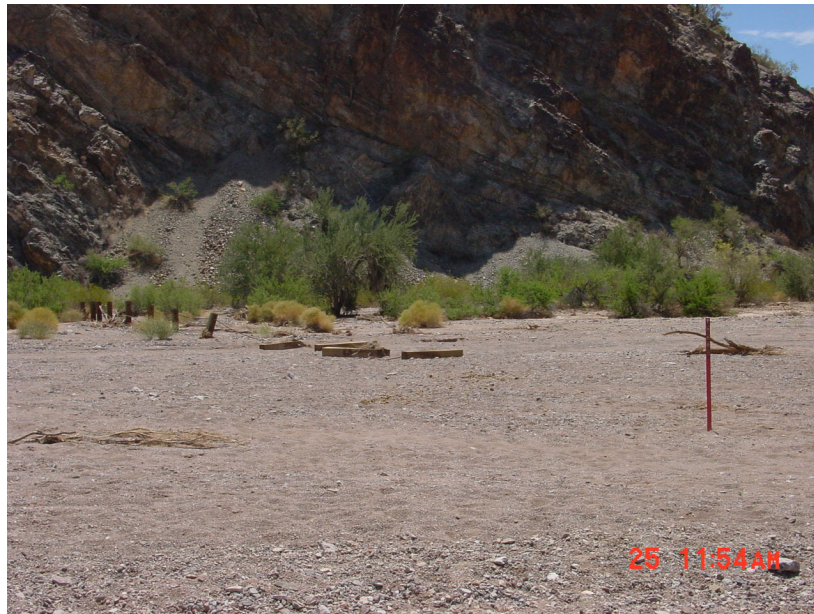
Barrier Material buried in sand and under Tamarisk, inside wilderness.

Prior to replacement of the barrier, the damaged wooden posts with attached cables, and three metal guardrail sections will be removed from within wilderness

area. The debris is approximately 500 yards from the wilderness boundary and partially buried in the sand and tangled in some small salt cedars next to the Bill Williams River. Removal of the materials will be accomplished using by a volunteer crew of 8-12 people and hand tools. If a volunteer crew cannot be found in a timely matter or the materials cannot be safely removed by hand, the removal would be accomplished using one vehicle (truck, ATV or wheeled tractor), a chainsaw, and a cutting torch. Approximately 3-4 vehicle trips would be required to remove the materials. The vehicle would be used to “pull” the wooden posts and cables from the sand. All tracks and surface disturbances will be brushed out. Either method will require one-two days within the wilderness to remove all materials.
